APPENDIX 9

PHASE 1B/2 CONSTRUCTION INSPECTION FORMS

Pine Street Canal Site,
1-0870-1 (541),
West Bank Capping:
Environmental Controls
Daily Inspection Checklist
11/24/03-

PINE STREET CANAL SITE – WEST BANK CAPPING
ENVIRONMENTAL CONTROLS DAILY INSPECTION CHECKLIST

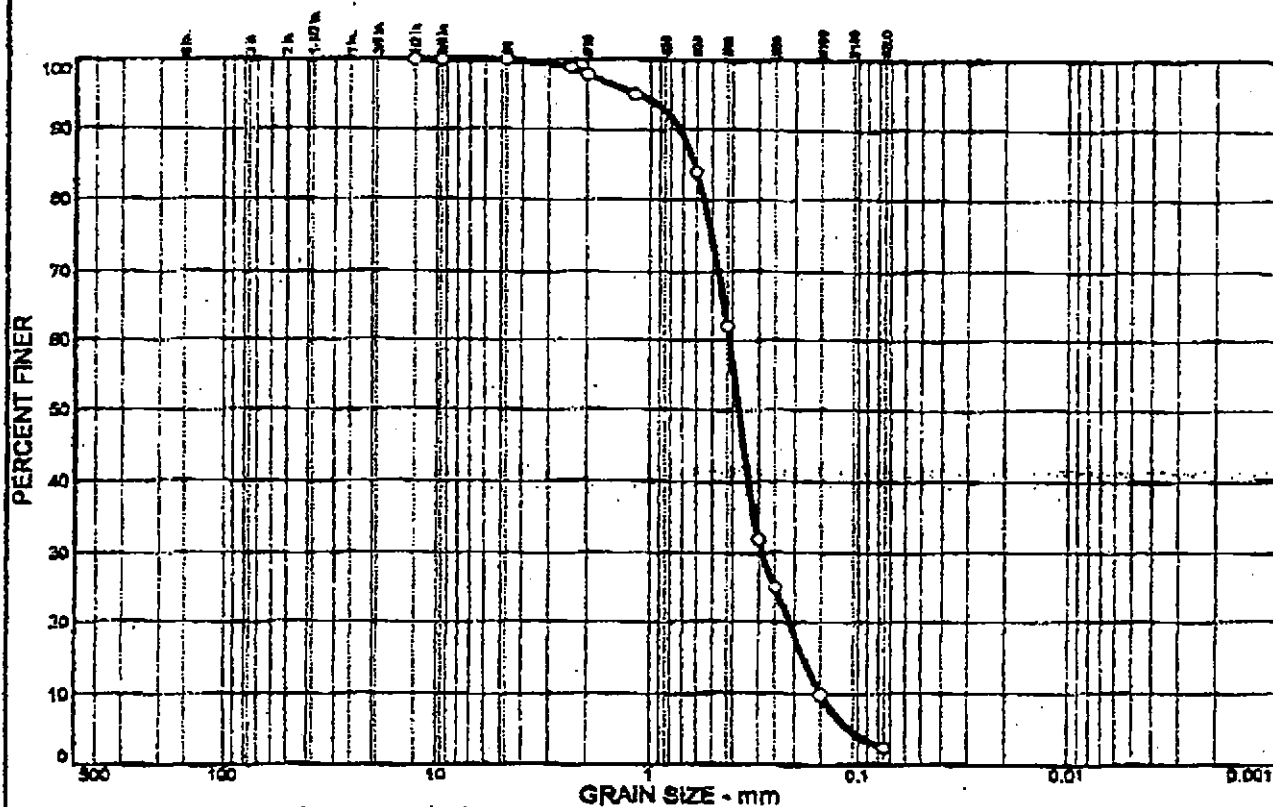
Grain Size Distribution Report

% COBBLES	% GRAVEL		% SAND			% FINES	
	CRS.	FINE	CRS.	MEDIUM	FINE	SILT	CLAY
0	0	0	2	36	59	3

SIEVE SIZE	PERCENT FINER	SPEC.* PERCENT	PASS7 (X=NO)
1/2 in.	100		
3/8 in.	100		
#4	100		
#8	99		
#10	98		
#16	95		
#30	84		
#40	62		
#50	32		
#60	25		
#100	10		
#200	2.6

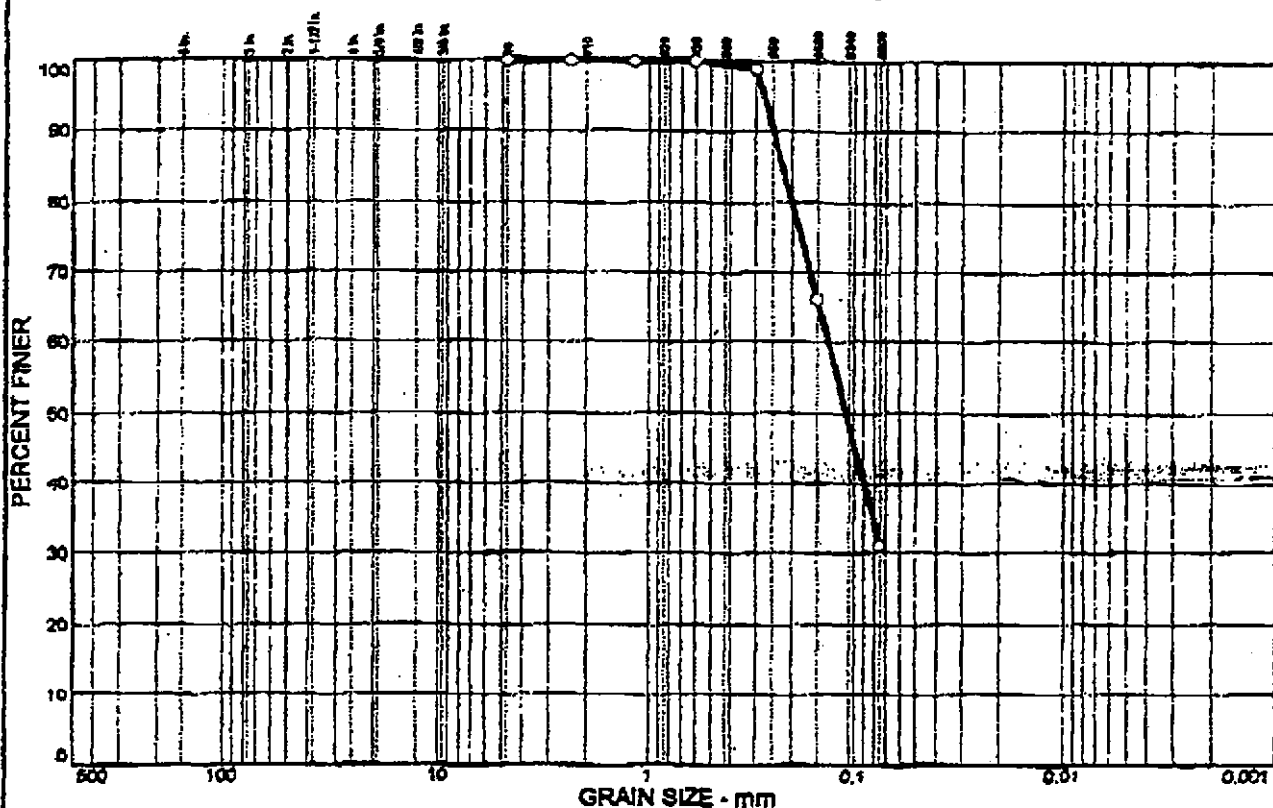
Grain Size Distribution Report

% COBBLES	% GRAVEL		% SAND			% FINES	
	CRS.	FINE	CRS.	MEDIUM	FINE	SILT	CLAY
0	0	0	0	0	69	31

SIEVE SIZE	PERCENT FINER	SPEC. PERCENT	PASS? (X=NO)
#4	100		
#8	100		
#16	100		
#30	100		
#50	99		
#100	66		
#200	31

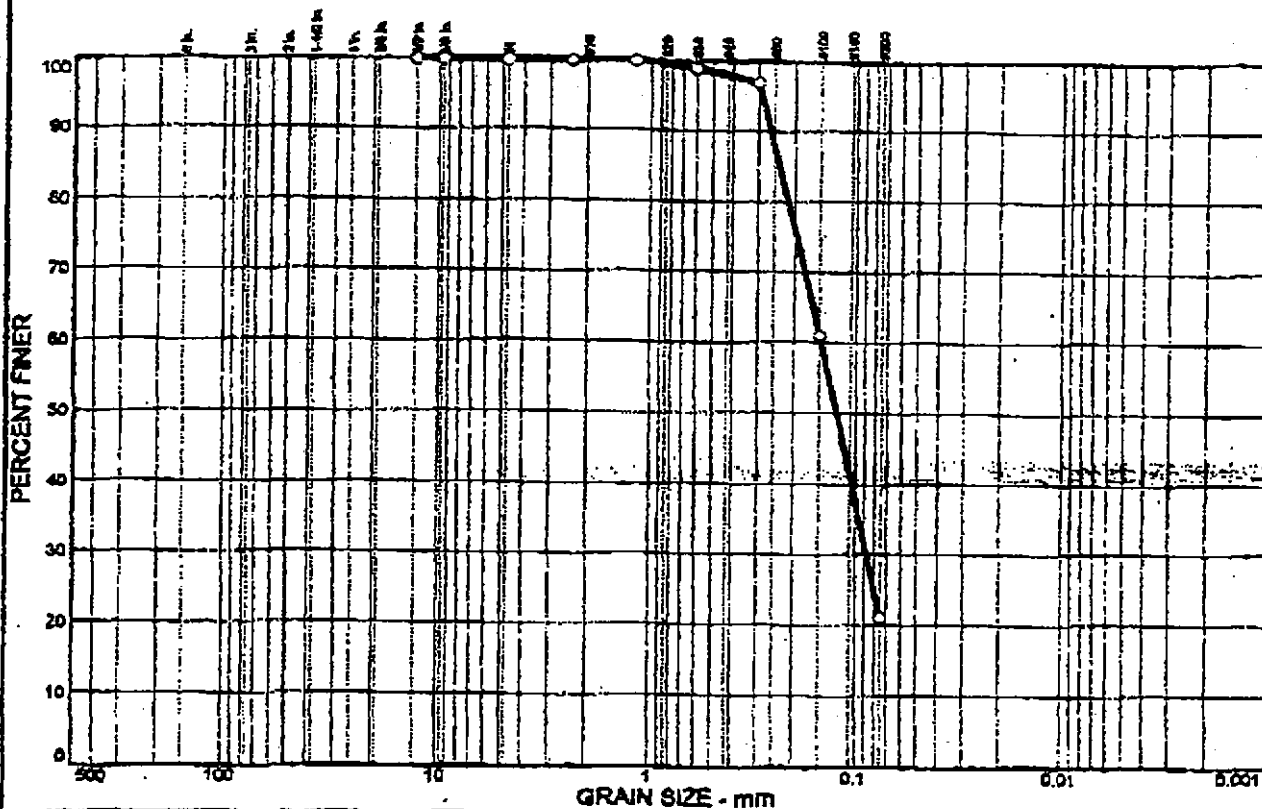
Grain Size Distribution Report

% COBBLES	% GRAVEL		% SAND			% FINES	
	CRS.	FINE	CRS.	MEDIUM	FINE	SILT	CLAY
0	0	0	0	2	77	21

SIEVE SIZE	PERCENT FINER	SPEC. PERCENT	PASS? (X=NO)
1/2 in.	100		
3/8 in.	100		
#4	100		
#8	100		
#16	100		
#30	99		
#50	97		
#100	61		
#200	21

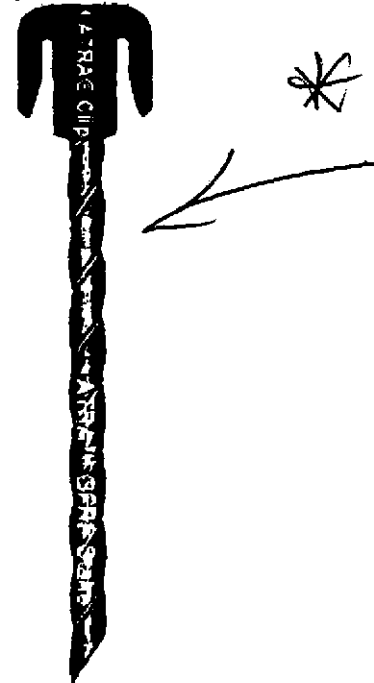
Figure 9
ATRA™ GFRP Anchor

The ATRA™ GFRP Stake shall be composed of glass fiber reinforced polymer with a sand-coating. Glass reinforcement content shall be 76% minimum by weight and shall be continuous longitudinal filament. The use of non-continuous filament is strictly prohibited. Polymer shall be vinyl ester, isophthalic polyester, or other matrix material. The outer surface of the Stake shall be sand coated and deformed by a helical wrap of glass. The ATRA™ GFRP Stake shall have a minimum tensile strength of 665 MPa (95 ksi) per ASTM D638. The Stake shall be non-magnetic, non-conducting and corrosion resistant. The Stake diameter shall be 12-13 mm (1/2 in). The length shall be per construction drawings. Prior to inserting the ATRA® Clip on the end of the stake, the stake end shall be ground or filed so it has a bevel and is free from all burrs.

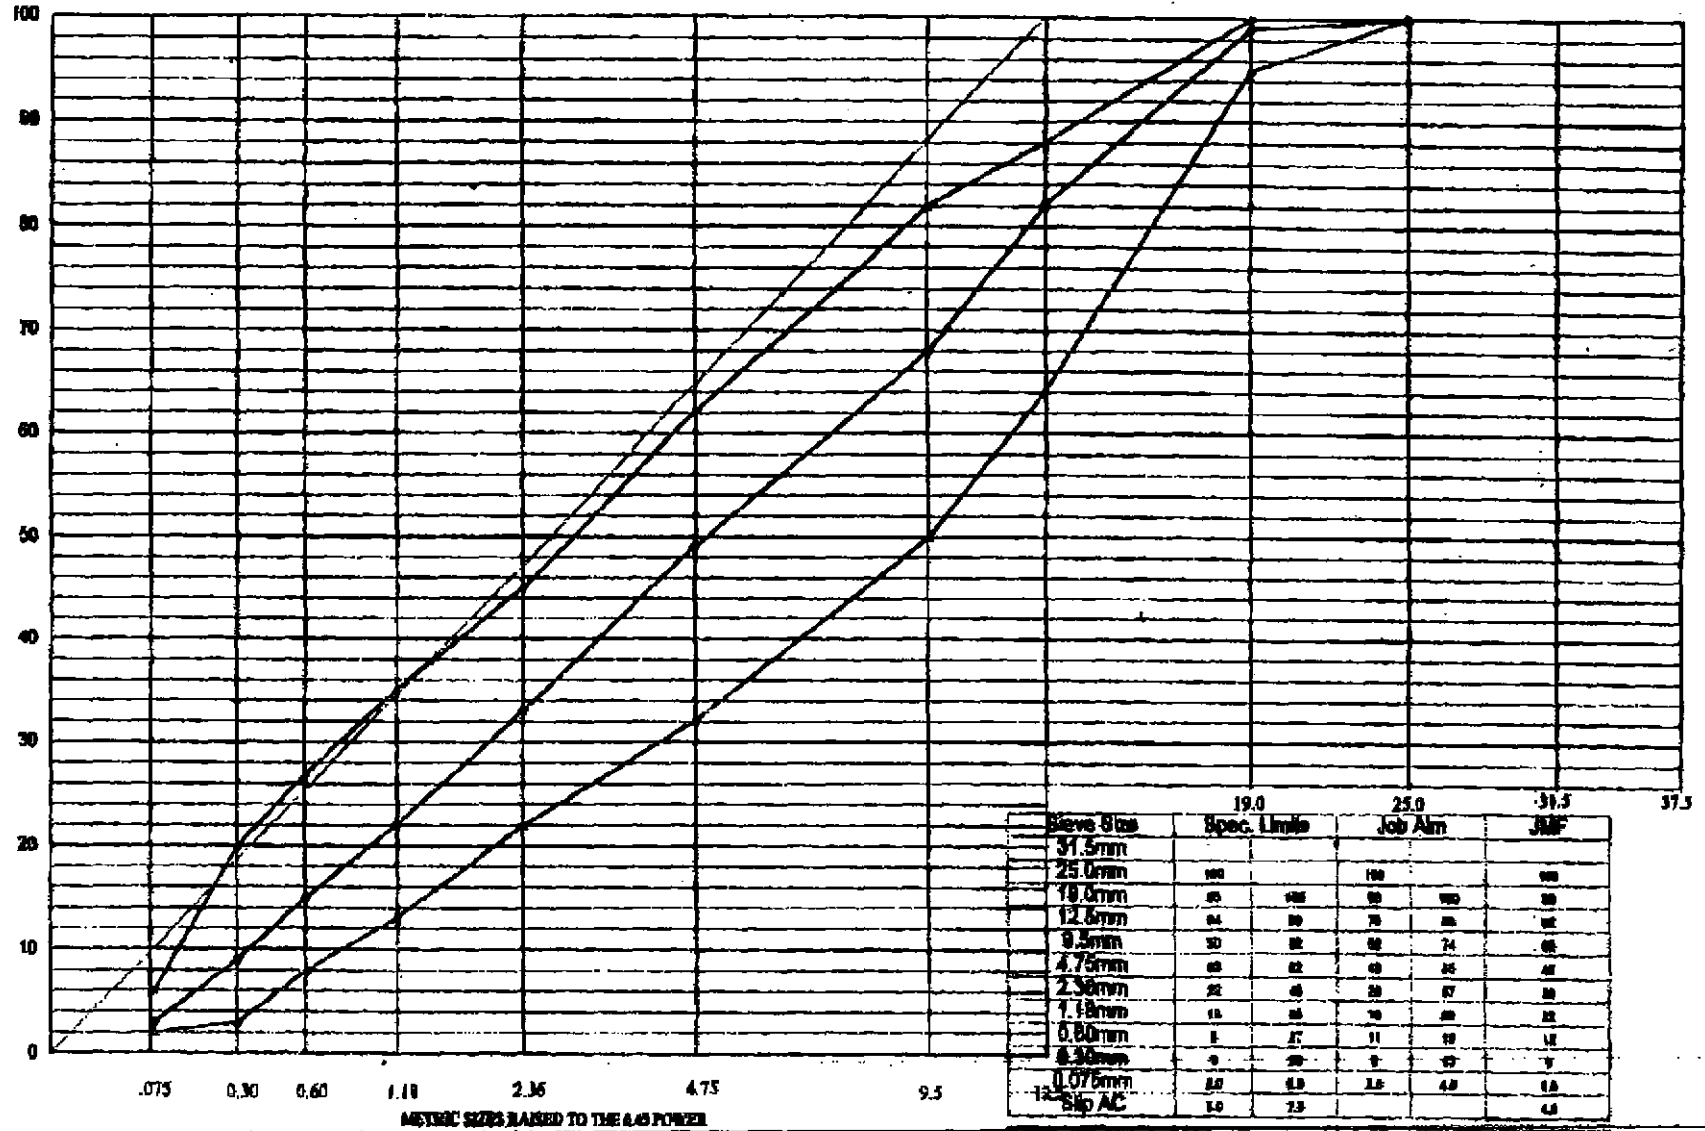
PARTICLE DISTRIBUTION CURVE

Producer Pike Industries Inc.
Location Williston, VT
Mix Type II Blow 75
Prepared By T.A. Costello
Design No. 00015
Date 1/31/2002

Marshall Values		Asphalt Cement	
Flow	2.8	Grade	58-54
Stability	11200	Source	Petro
VMA	14.2		
% Air Voids	4.0

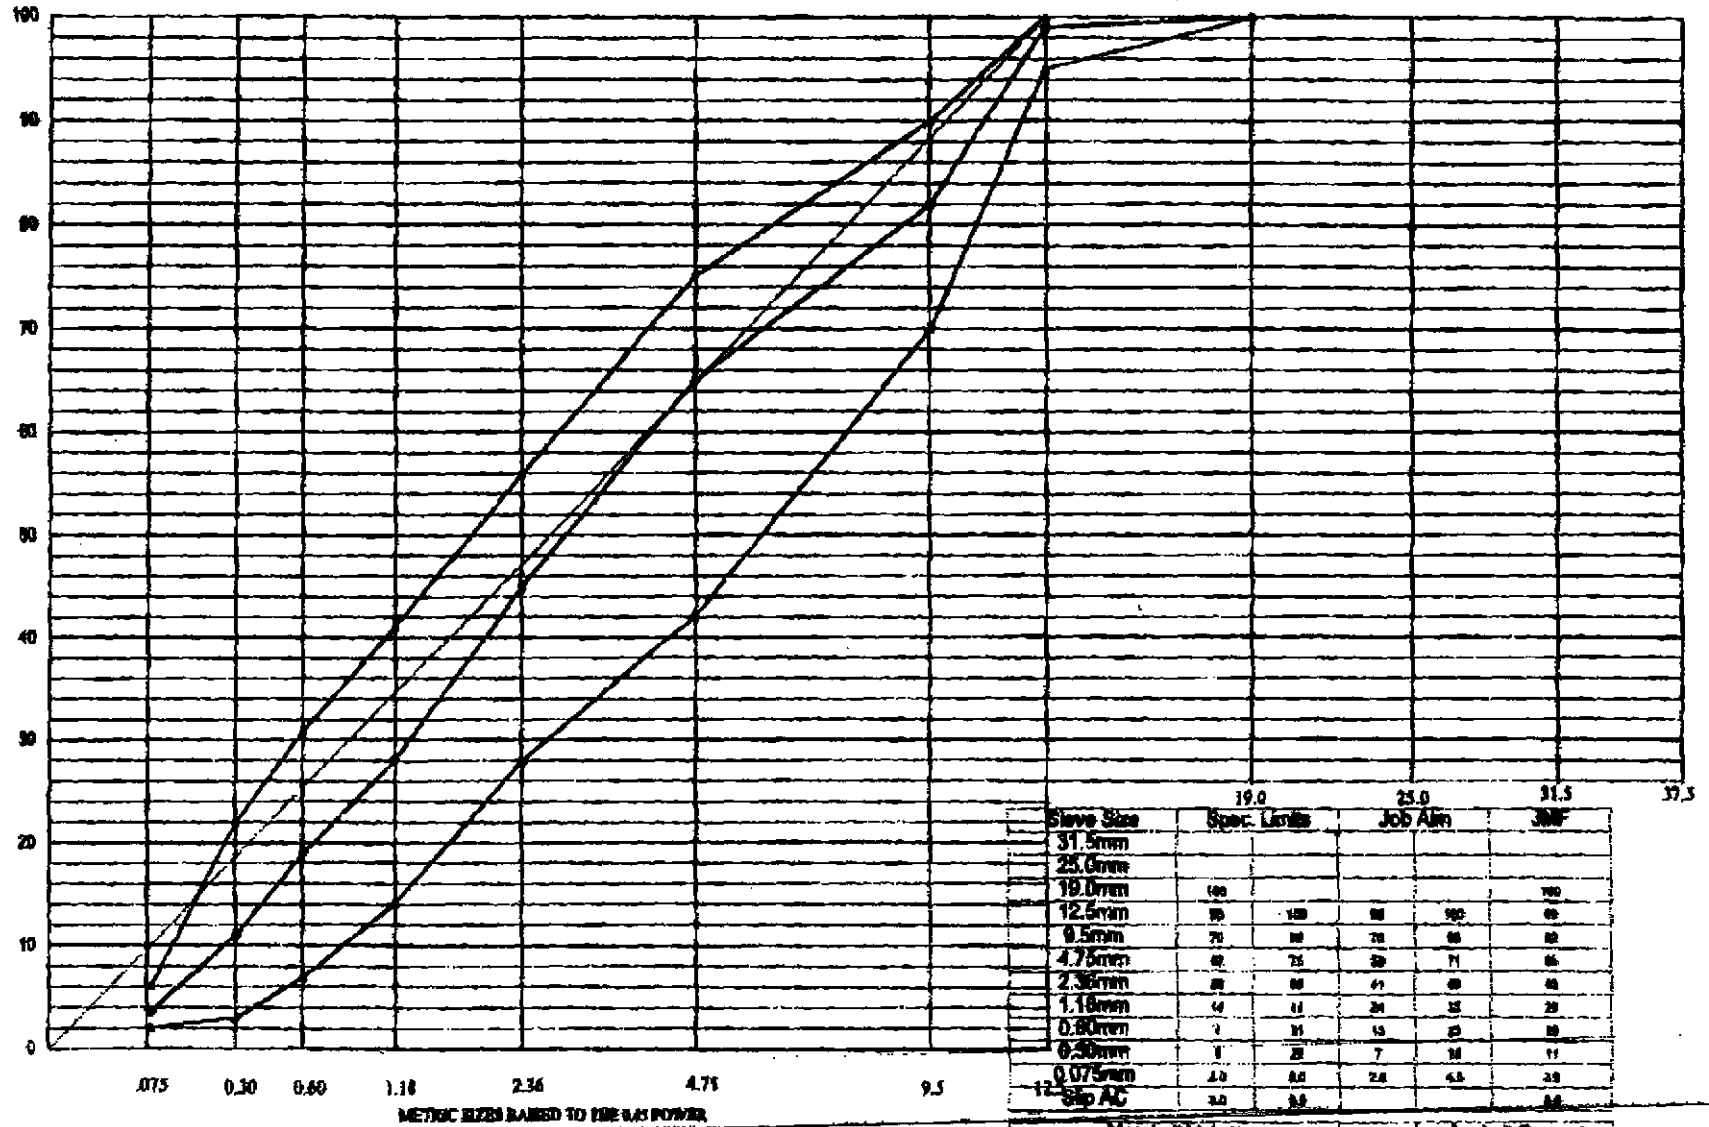
PARTICLE DISTRIBUTION CURVE

Producer: Pike Industries Inc.
Location: Williston, VT
Mix Type: III
Blow: 75
Prepared By: T.A. Cusumano
Design No.: 00817
Date: 1/31/2002

Marshall Values
Flow: 2.8
Stability: 11600
VMA: 15.8
% Air Voids: 4.0
Grade: 68-54
Source: Petro

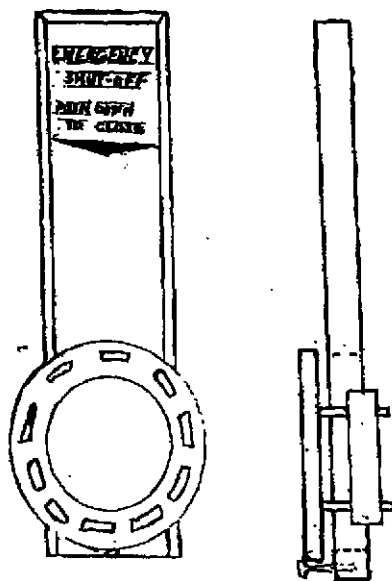
EMERGENCY CUT-OFF ✓

The special emergency shut off valve was designed to meet the needs for a fast acting, low head shutoff gate for use as an emergency shut off for hazardous material spills. Will fasten to PVC, corrugated metal or corrugated polyethylene pipe.

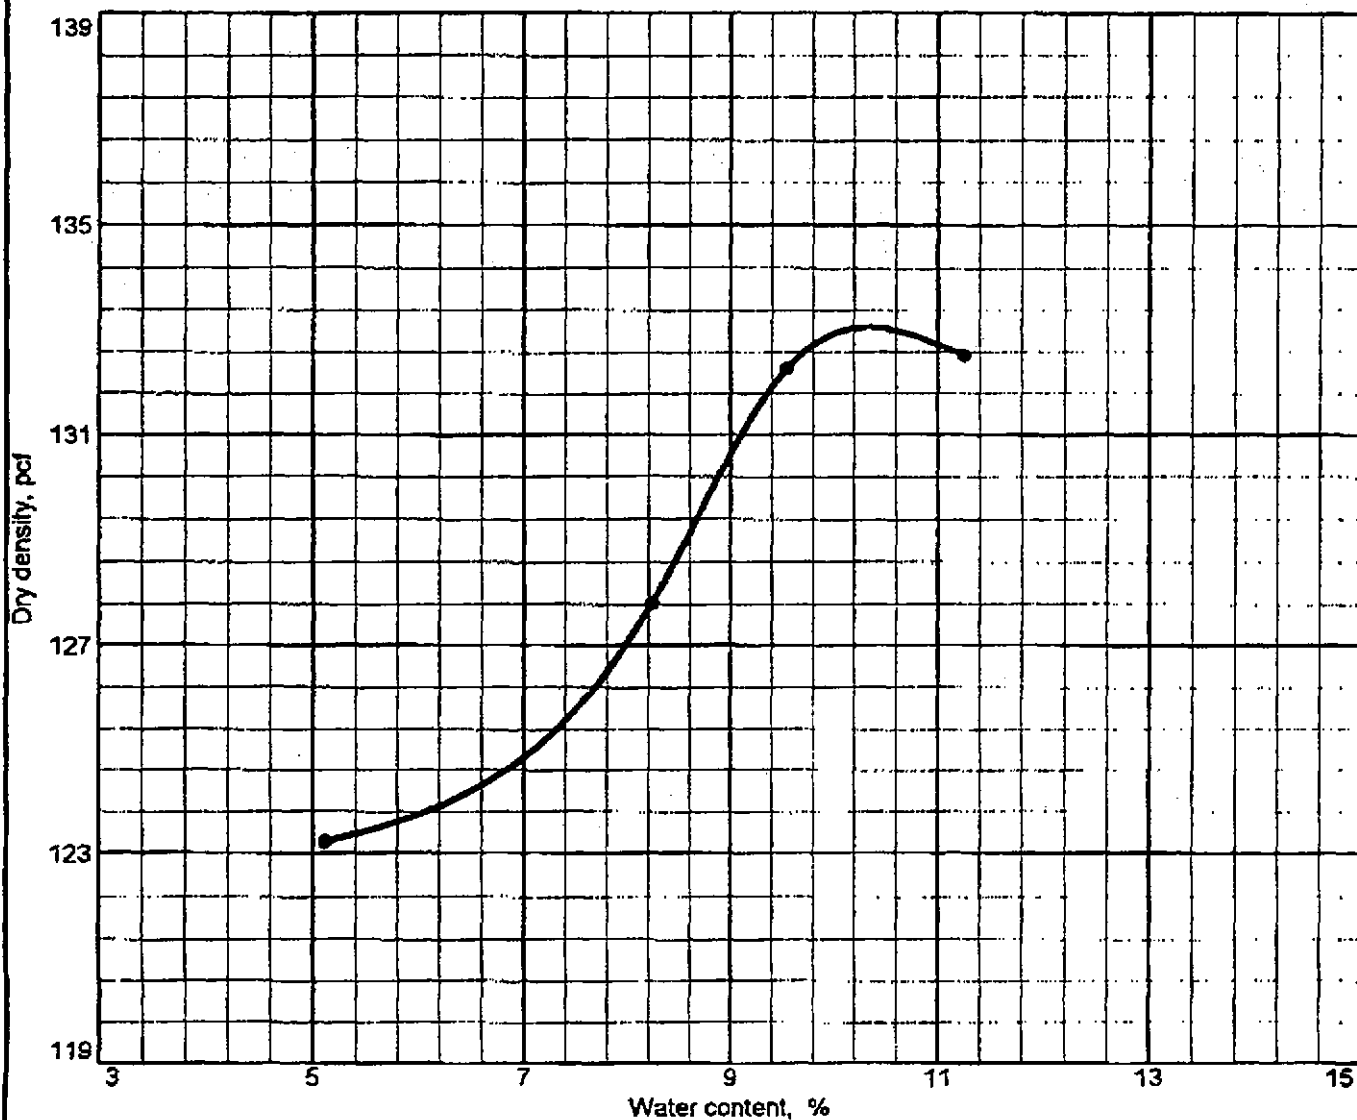
Laboratory Compaction Report

Test specification: ASTM D 1557-78 Method A Modified

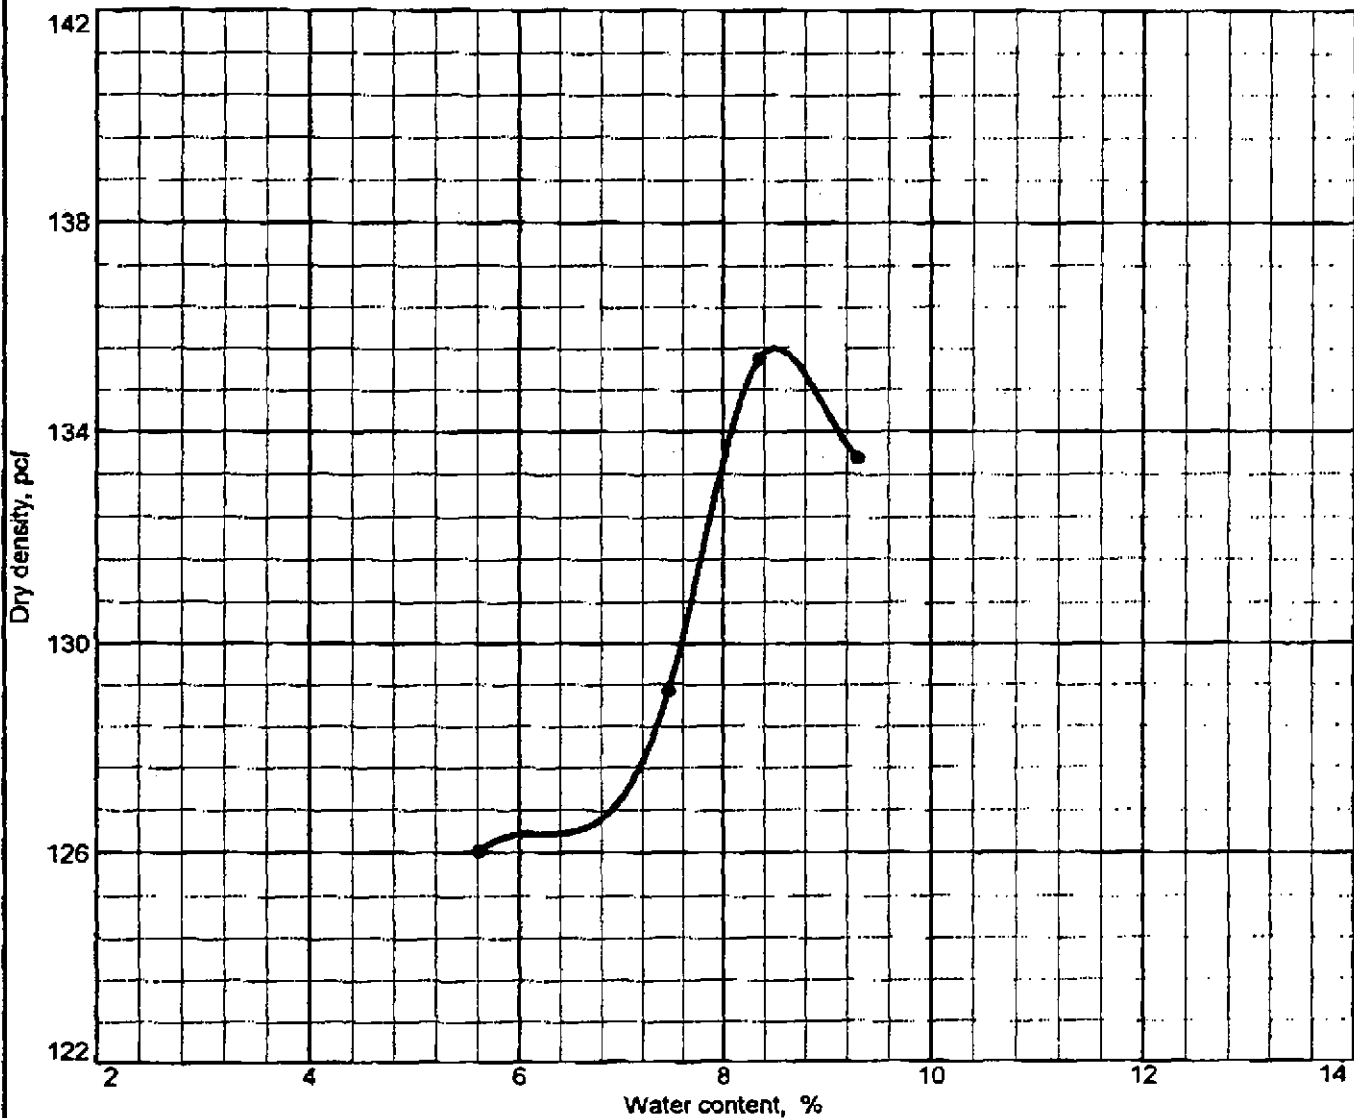
Laboratory Compaction Report

Test specification: ASTM D 1557-91 Procedure A Modified

Elev/ Depth	Classification		Nat. Moist	Sp.G.	LL	PI	% > No.4	% < No.200
	USCS	AASHTO

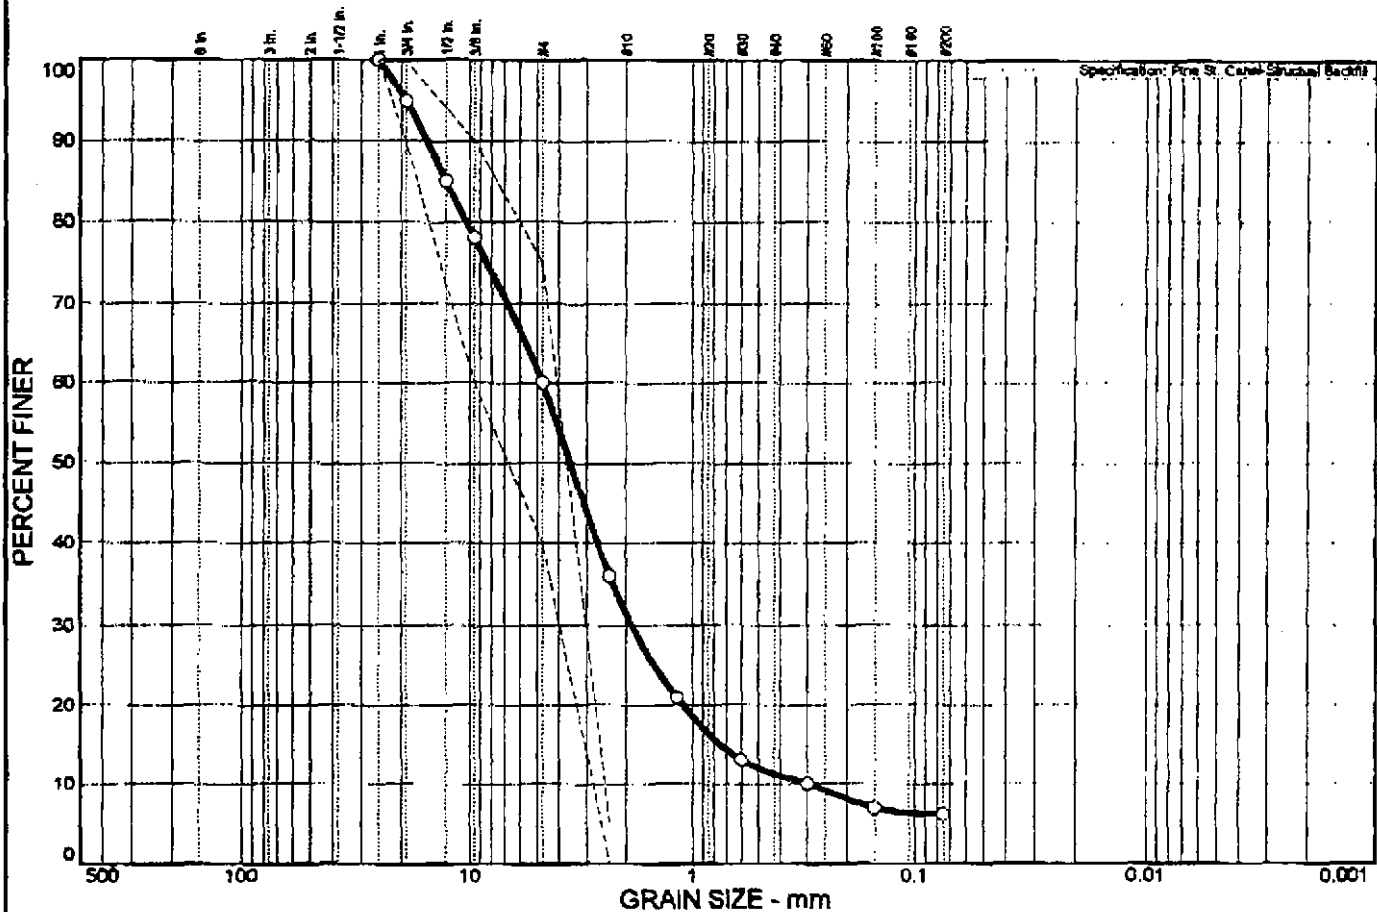
Grain Size Distribution Report

% COBBLES	% GRAVEL	% SAND	% SILT	% CLAY
0	40	54	6

SIEVE SIZE	PERCENT FINER	SPEC.* PERCENT	PASS? (X=NO)
1 in.	100	100 - 100	
3/4 in.	95	90 - 100	
1/2 in.	85		
3/8 in.	78	60 - 90	
#4	60	40 - 75	
#8	36	0-5	X
#16	21		
#30	13		
#50	10		
#100	7		
#200	6.2	0-5 ←	X

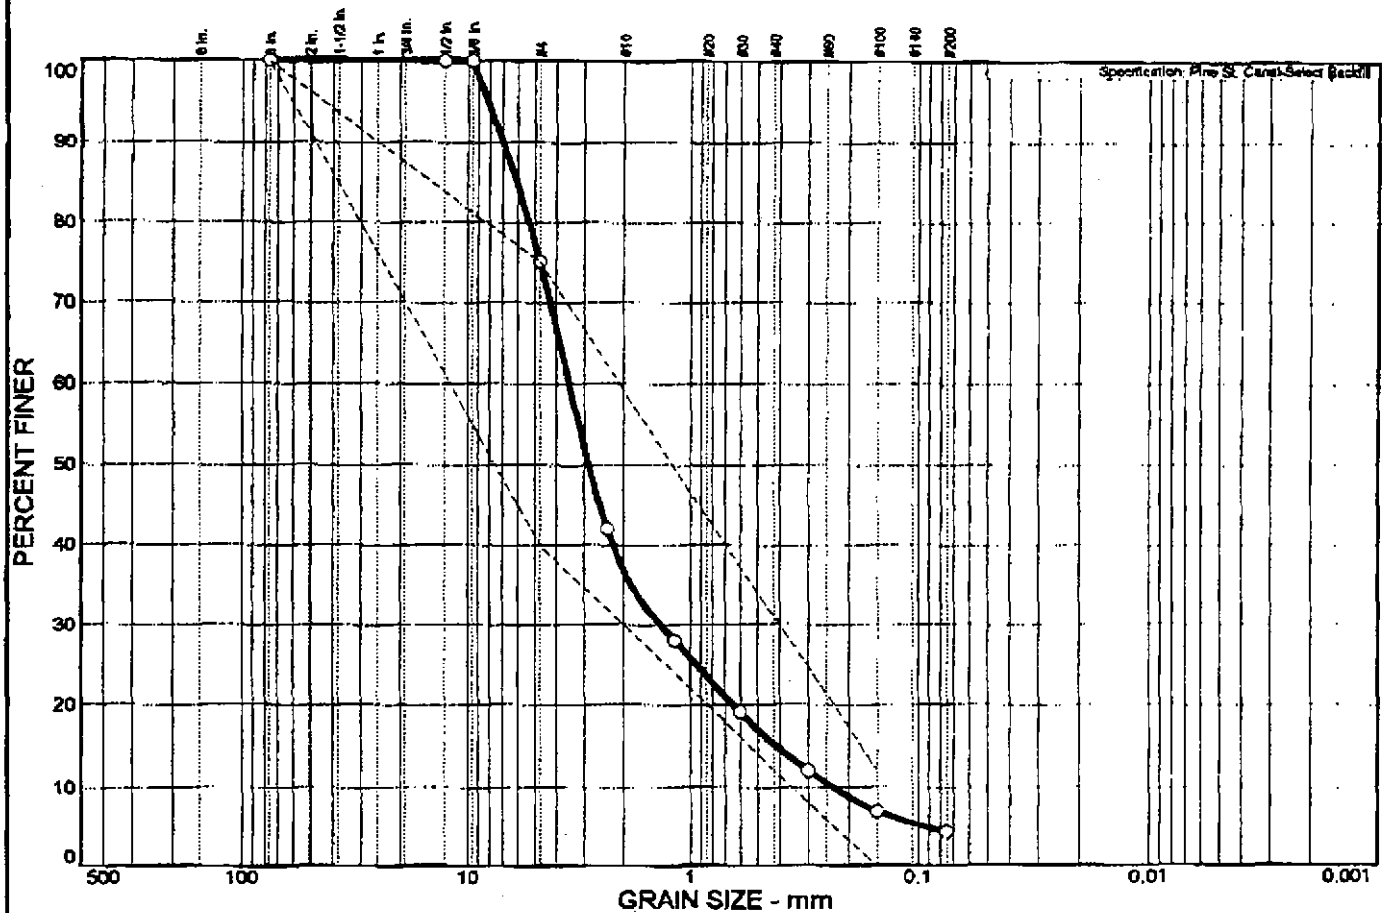
Grain Size Distribution Report

% COBBLES	% GRAVEL	% SAND	% SILT	% CLAY
0	25	71	4

SIEVE SIZE	PERCENT FINER	SPEC.* PERCENT	PASS? (X=NO)
3 in.	100	100 - 100	
1 1/2 in.	100		
3/8 in.	100		
#4	75	40 - 75	
#8	42		
#16	28		
#30	19		
#50	12		
#100	7	0 - 12	
#200	4.4

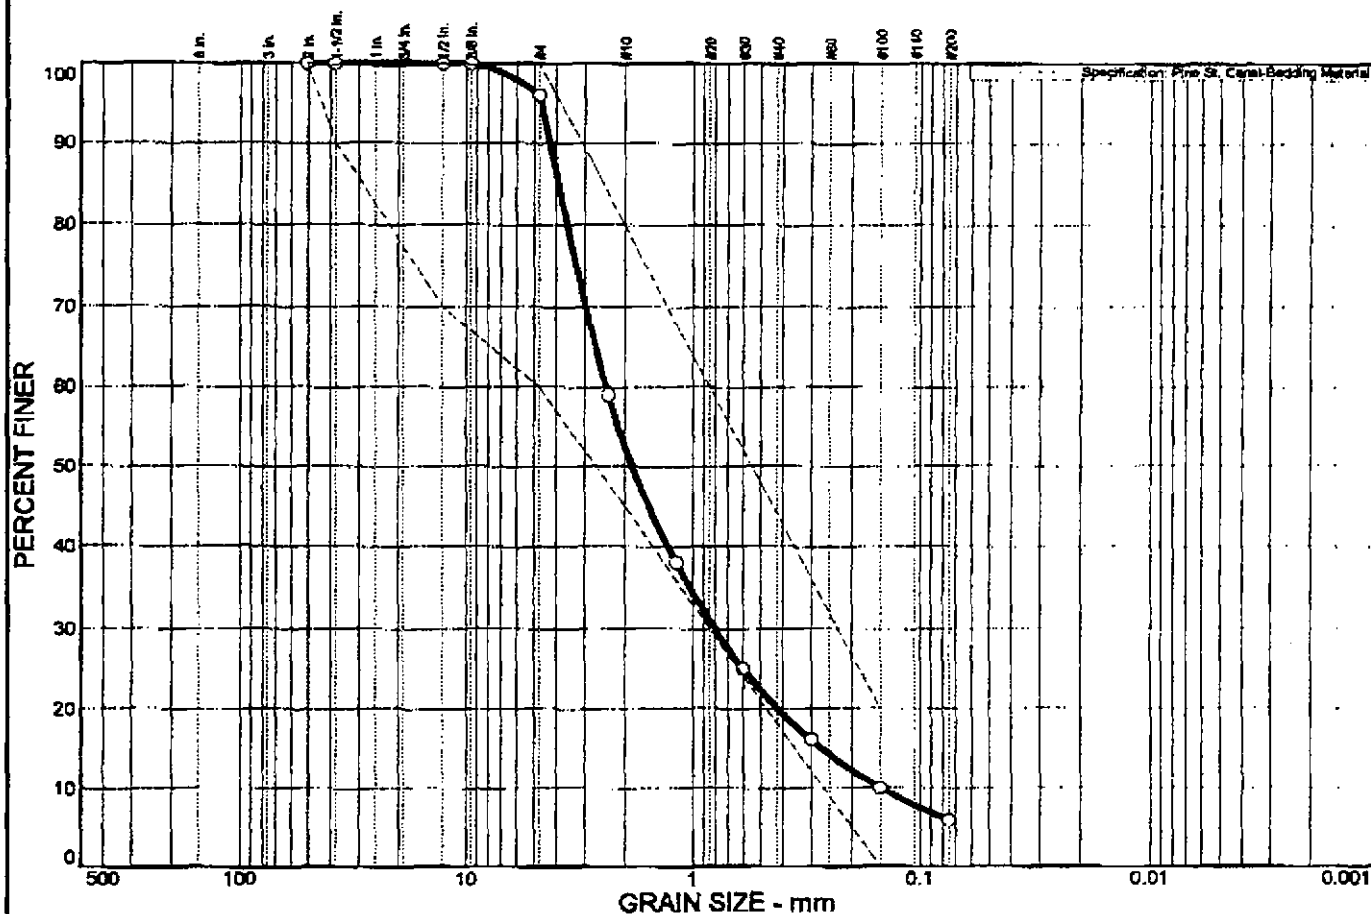
Grain Size Distribution Report

% COBBLES	% GRAVEL	% SAND	% SILT	% CLAY
0	4	90	6

SIEVE SIZE	PERCENT FINER	SPEC. PERCENT	PASS? (X=NO)
2 in.	100	100 - 100	
1-1/2 in.	100	90 - 100	
1/2 in.	100	70 - 100	
3/8 in.	100		
#4	96	60 - 100	
#8	59		
#16	38		
#30	25		
#50	16		
#100	10	0 - 20	
#200	5.8

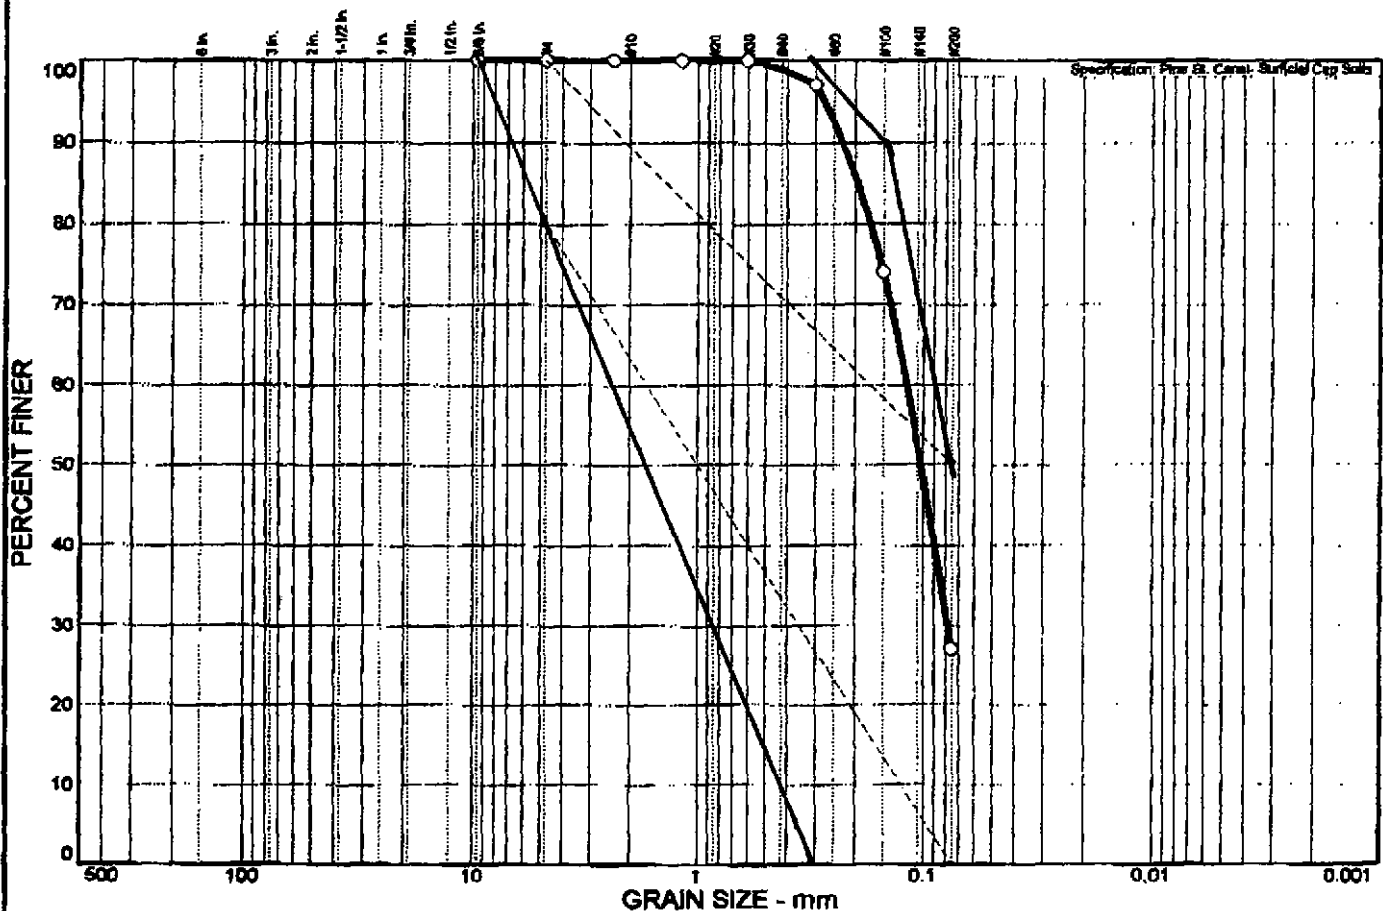
Grain Size Distribution Report

% COBBLES	% GRAVEL	% SAND	% SILT	% CLAY
0	0	73	27

SIEVE SIZE	PERCENT FINER	SPEC. PERCENT	PASS? (X=NO)
3/8 in.	100	100 - 100	
#4	100	80 - 100	
#8	100		
#16	100		
#30	100		
#50	97	0 - 100	
#100	74	0 - 90	
#200	27	0 - 50

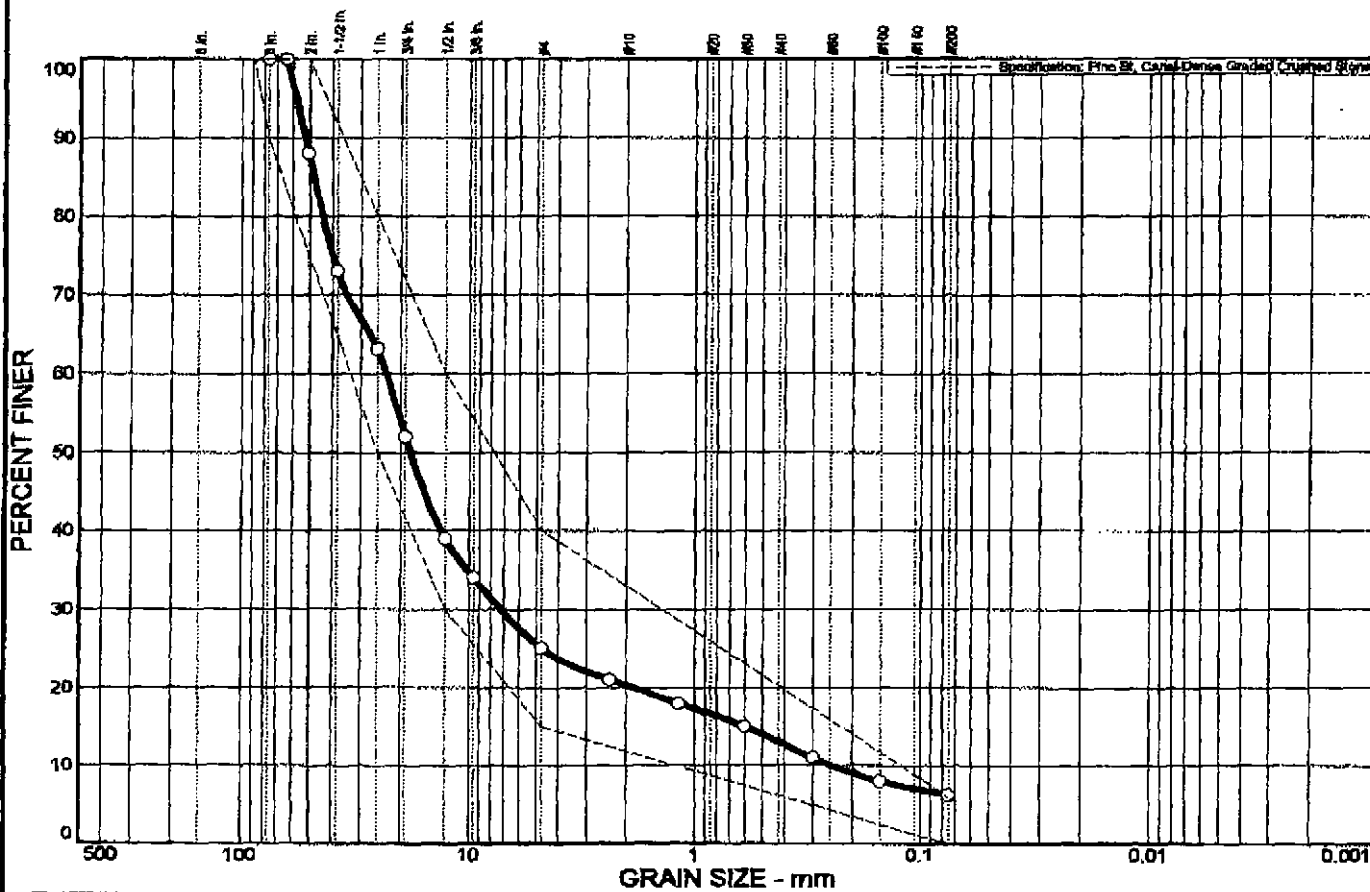
Grain Size Distribution Report

% COBBLES	% GRAVEL	% SAND	% SILT	% CLAY
0	75	19	6

SIEVE SIZE	PERCENT FINER	SPEC.* PERCENT	PASS? (X=NO)
3 in.	100	90 - 100	
2-1/2 in.	100		
2 in.	88	75 - 100	
1-1/2 in.	73		
1 in.	63	50 - 80	
3/4 in.	52		
1/2 in.	39	30 - 60	
3/8 in.	34		
#4	25	15 - 40	
#8	21		
#16	18		
#30	15		
#50	11		
#100	8		
#200	6.3	0 - 6

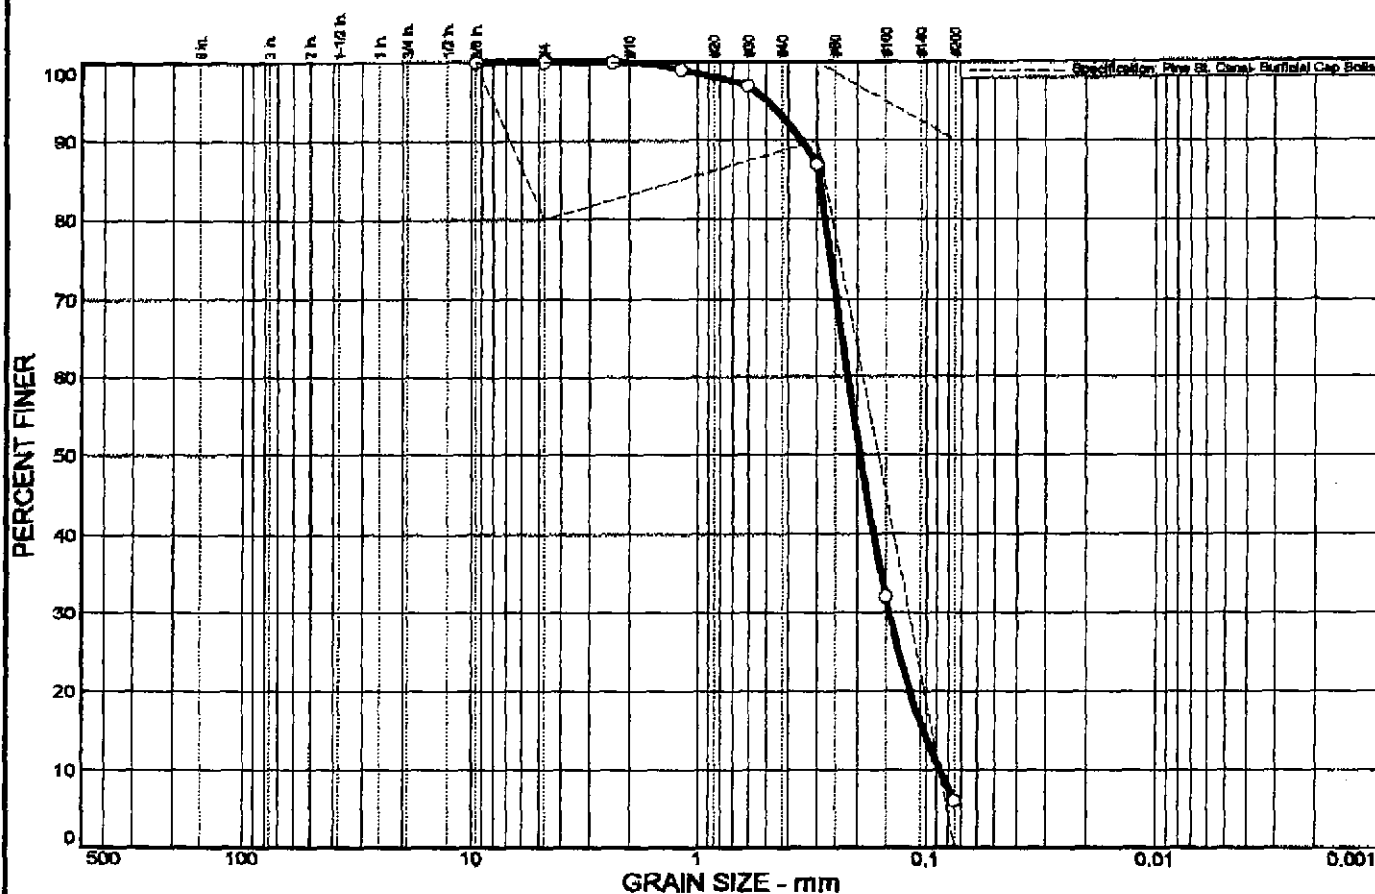
Grain Size Distribution Report

% COBBLES	% GRAVEL	% SAND	% SILT	% CLAY
0	0	94	6

SIEVE SIZE	PERCENT FINER	SPEC.* PERCENT	PASS? (X=NO)
3/8 in.	100	100 - 100	
#4	100	80 - 100	
#8	100		
#16	99		
#30	97		
#50	87	90 - 100	X
#100	32		
#200	6.1	0 - 90

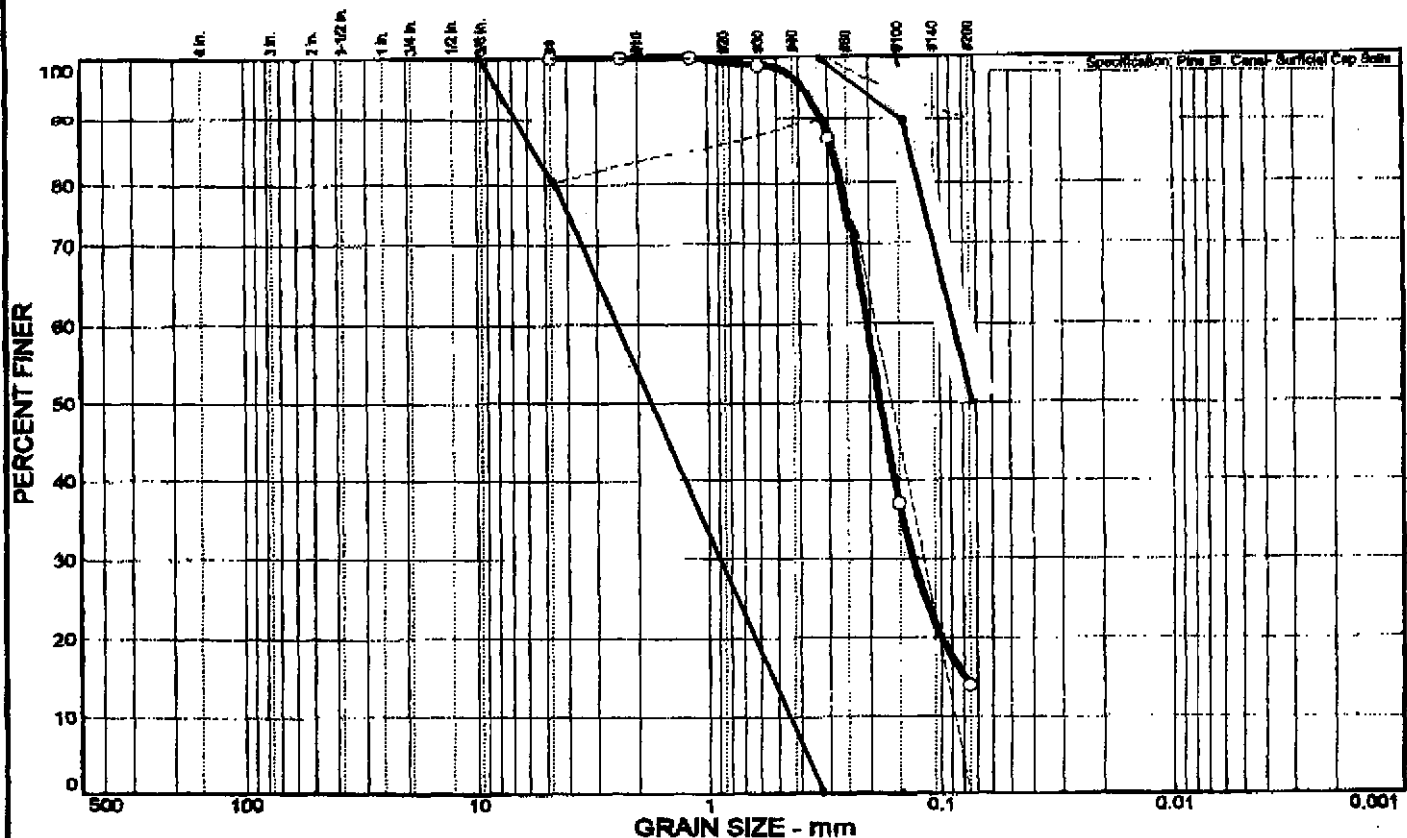
Grain Size Distribution Report

% COBBLES	% GRAVEL	% SAND	% SILT	% CLAY
0	0	86	14

SIEVE SIZE	PERCENT FINER	SPEC.* PERCENT	PASS? (X=NO)
#4	100	80 - 100	
#8	100		
#16	100		
#30	99		
#50	87	70 - 100	X
#100	37	0 - 90	
#200	14	0 - 90

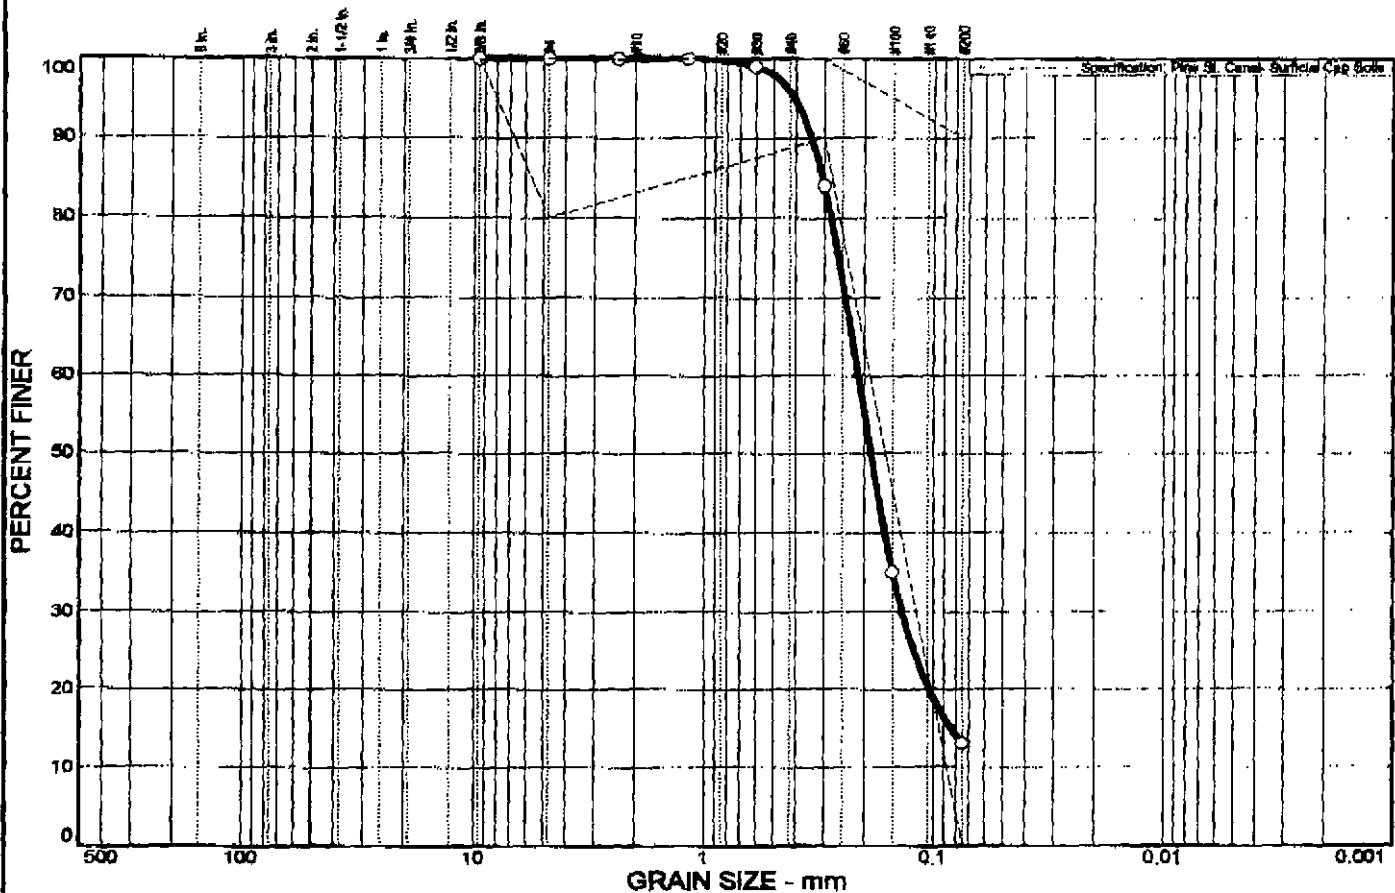
Grain Size Distribution Report

% COBBLES	% GRAVEL	% SAND	% SILT	% CLAY
0	0	87	13

SIEVE SIZE	PERCENT FINER	SPEC.* PERCENT	PASS? (X=NO)
3/8 in.	100	100 - 100	
#4	100	80 - 100	
#8	100		
#16	100		
#30	99		
#50	84	90 - 100	X
#100	35		
#200	13	0 - 90

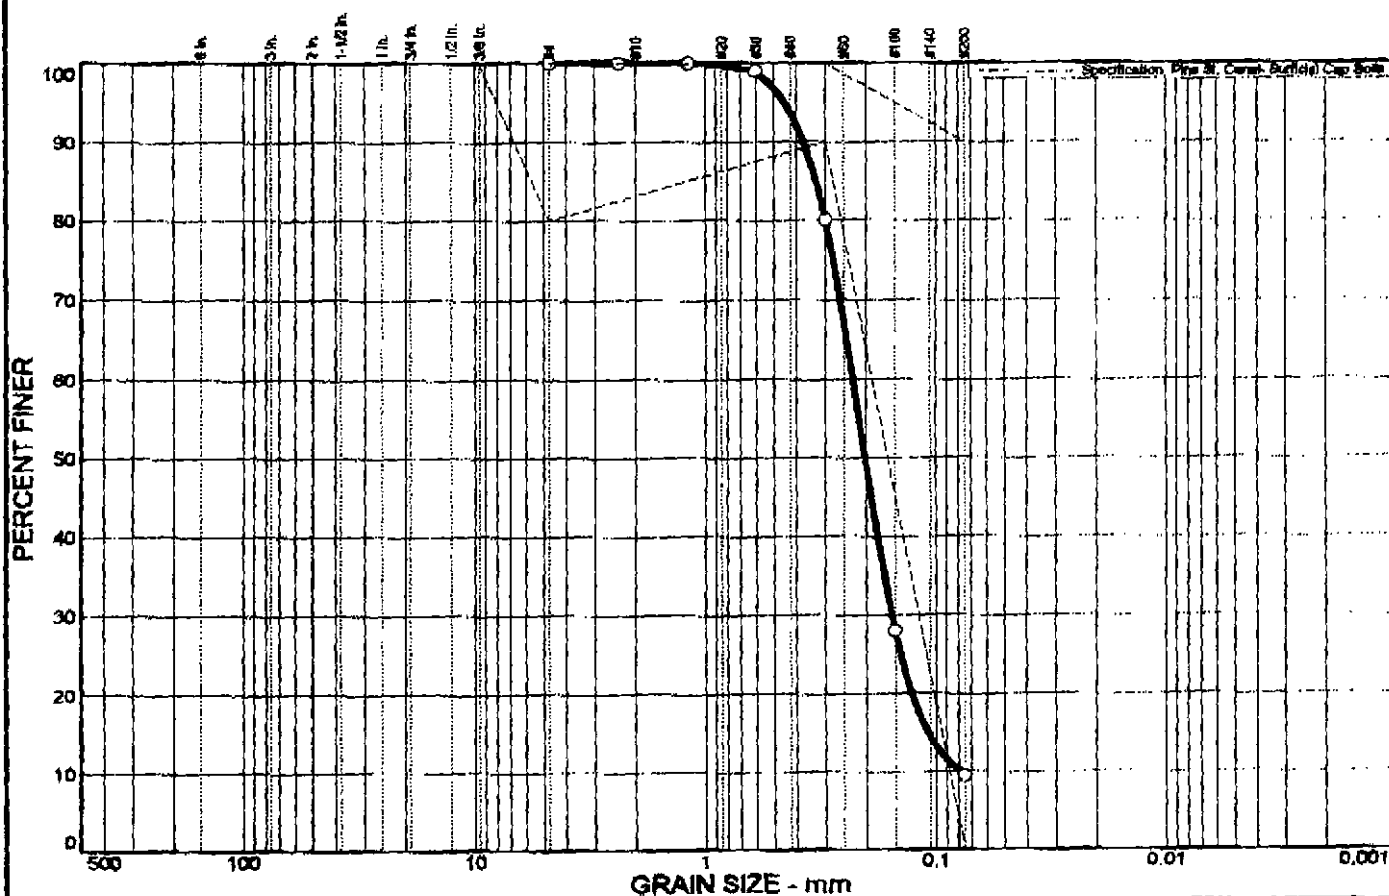
Grain Size Distribution Report

% COBBLES	% GRAVEL	% SAND	% SILT	% CLAY
0	0	90	10

SIEVE SIZE	PERCENT FINER	SPEC. PERCENT	PASS? (X=NO)
#4	100	80 - 100	
#8	100		
#16	100		
#30	99		
#50	80	90 - 100	X
#100	28		
#200	9.5	0 - 90
